A Case study and Lessons Learned Support of a Retaining Wall-Maid of the Mist Winter Storage D/B Project

Ground Improvements Presented by; Hosam Salman

November, 2019

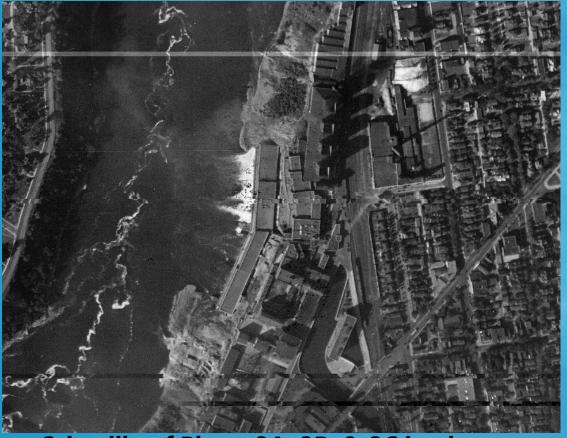
• Schoellkopf Plants 3A, 3B, & 3C in place

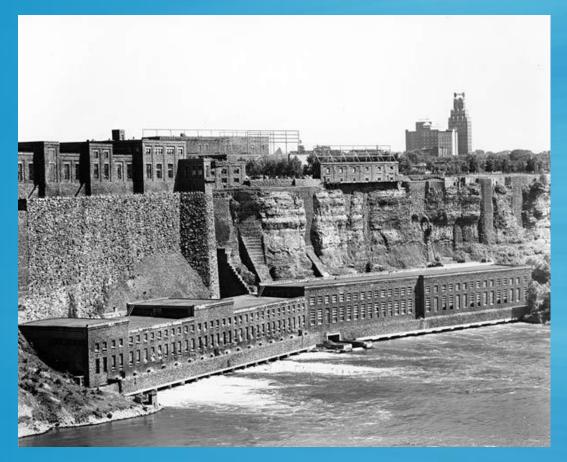
• Schoellkopf Plants 3A, 3B, & 3C before collapse

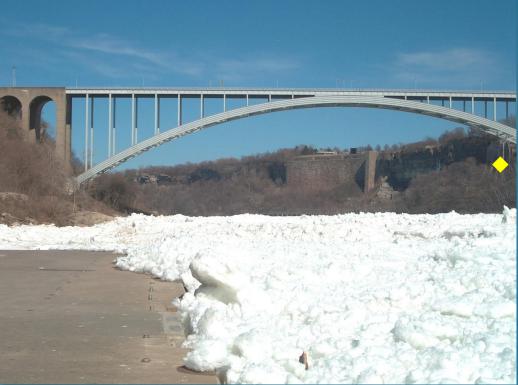
Ice accumulates in the Gorge as a result of ice flowing over the Falls

The ice bonds together, piles up, and jams

Water is forced to flow under and through the ice
At times the ice creates a temporary dam and causes the river level to rise

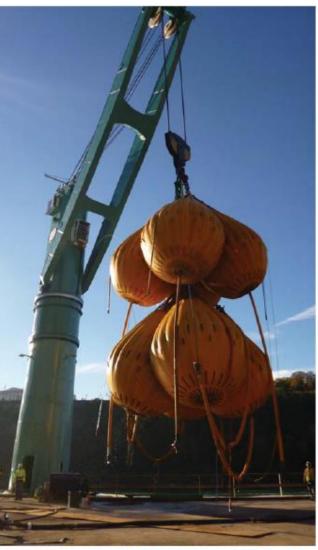
Figure 5: Maid of the Mist Crane Load Test Picture.

Crane testing was performed on October 10, 2013. The pedestal crane was loaded to 110 percent of its rated capacity, and rotated 360 pedestal degrees. Expected deflections modeled. were calculated and compared with onsite measurements. The calculated lateral deflections of approximately three quarters of an inch matched those observed during testing. The crane pedestal is structurally independent from the retaining wall, and the deflections from crane testing loads returned to zero after the load was removed.
